Memorandum

Re: Tennis Court Drainage Review Countryside Elementary School Campus Project No. 5146.000

Date: May 20, 2016

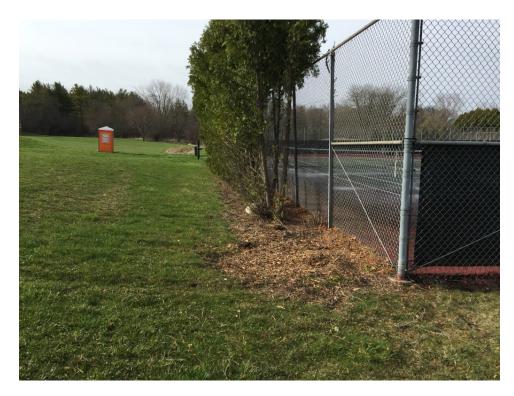
Photo 1 - Northeast Corner Looking South

An existing evergreen hedge is located along the east, west and south side of the courts. Over the years, the evergreens have grown and dropped their needles raising the ground above the original court grade and matching the slip sheet court elevation. This could be prohibiting drainage within the stone layer from fully drying out.

The courts appear to have been designed with a clearly defined perimeter swale around them. Over the years it looks as though the perimeter evergreens have grown impeding the tennis court drainage from reaching the drainage swale. We would recommend that the existing evergreens and their root zone be completely removed and the spoil materials be removed exposing both the upper pavement surface and the original court pavement. This should assist with promoting positive drainage off of the surface and out of the sandwiched stone layer.
